Technical Memo 3

SUBJECT: Portage Creek Stream Stability Assessment
Hampton Creek Wetland Areas
City of Portage, Kalamazoo County, Michigan – **DRAFT**

DATE: December 2, 2019

PROJECT NO.: 181663

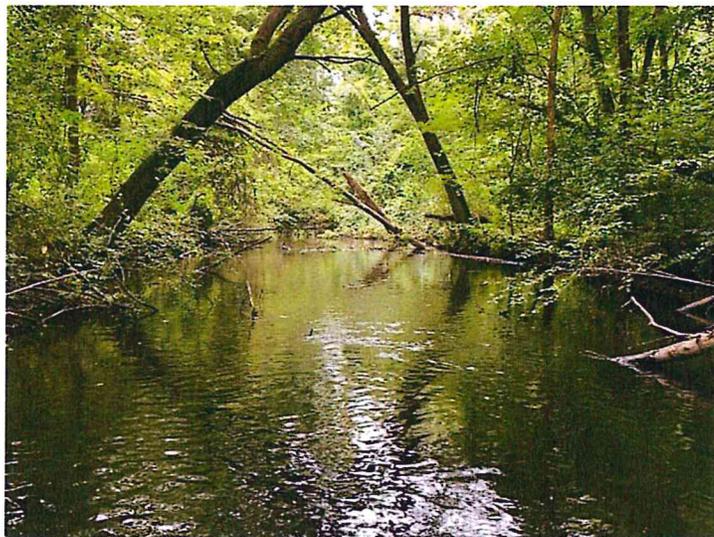
Groundwater seepage was observed along channel banks throughout the wooded corridor, resulting in minor slumps.
